**Virginia Department of Transportation**  
**X Lite Tangent 50' (15.24 m) System**

**TR-P36132-01-NC**

Test Article:     X Lite Tangent 50' (15.24 m) System          Project No.     P36132-01      
 Test Program:     100 km/h 5° Guardrail Terminal Impact Test          Test Date:     08/11/16

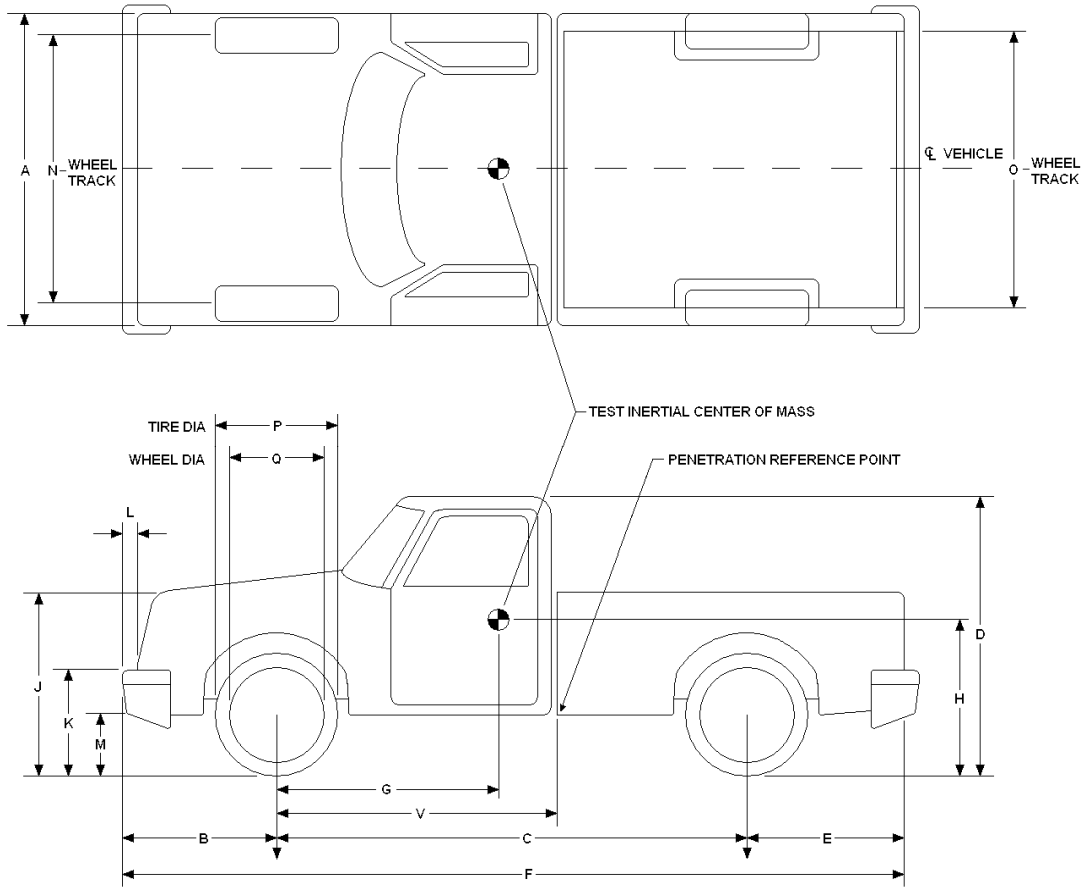
### TEST VEHICLE GEOMETRY

mm	in.		mm	in.		mm	in.		mm	in.
A	2005	78.9	E	1148	45.2	J	1185	46.7	N	1745	68.7
B	1008	39.7	F	5541	218.1	K	752	29.6	O	1680	66.1
C	3385	133.3	G	1329	52.3	L	100	3.9	P	745	29.3
D	1913	75.3	H	733	28.9	M	465	18.3	Q	440	17.3

The test was conducted on August 11, 2016. The as-tested test inertial weight of the vehicle was 2,042.0 kg (4,501.8 lbs.). The height of the front bumper was 465 mm (18.3 in.) to the lower edge and 752 mm (29.6 in.) to the upper edge. Additional dimensions and test vehicle information are presented in Data Sheets No. 1 and 2.

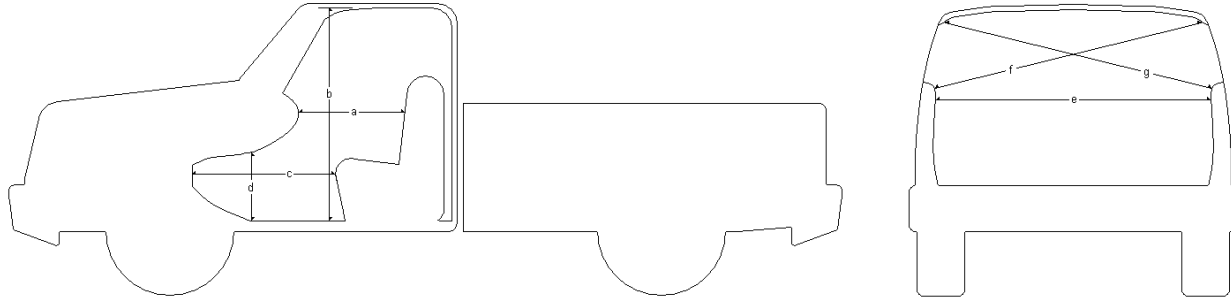
#### OCCUPANT COMPARTMENT DEFORMATION INDEX

The seven subindices a, b, c, d, e, f and g indicate the percentage of reduction of seven interior dimensions shown on the following figure:

- a = distance between the dashboard and a reference point at the rear of the occupant compartment, such as top of rear seat, or the rear part of the cab on a pickup;
- b = distance between the roof and the floor panel;
- c = distance between a reference point at the rear of the occupant compartment and the motor panel;
- d = distance between the lower dashboard and the floor panel;
- e = interior width;
- f = distance between the lower edge of right window and the upper edge of left window; and
- g = distance between the lower edge of left window and the upper edge of right window

Sub-Indices	Pre-Test		Post-Test		Percent Reduction
	mm	in.	mm	in.	
A	1058	41.7	1055	41.5	0.28%
B	1131	44.5	1128	44.4	0.27%
C	1632	64.3	1623	63.9	0.55%
D	392	15.4	393	15.5	-0.26%
E	1717	67.6	1718	67.6	-0.06%
F	1595	62.8	1598	62.9	-0.19%
G	1597	62.9	1590	62.6	0.44%
Max Deformation	1632	64.3	1623	63.9	0.55%
OCDI	FS0000000				
Comments:	None

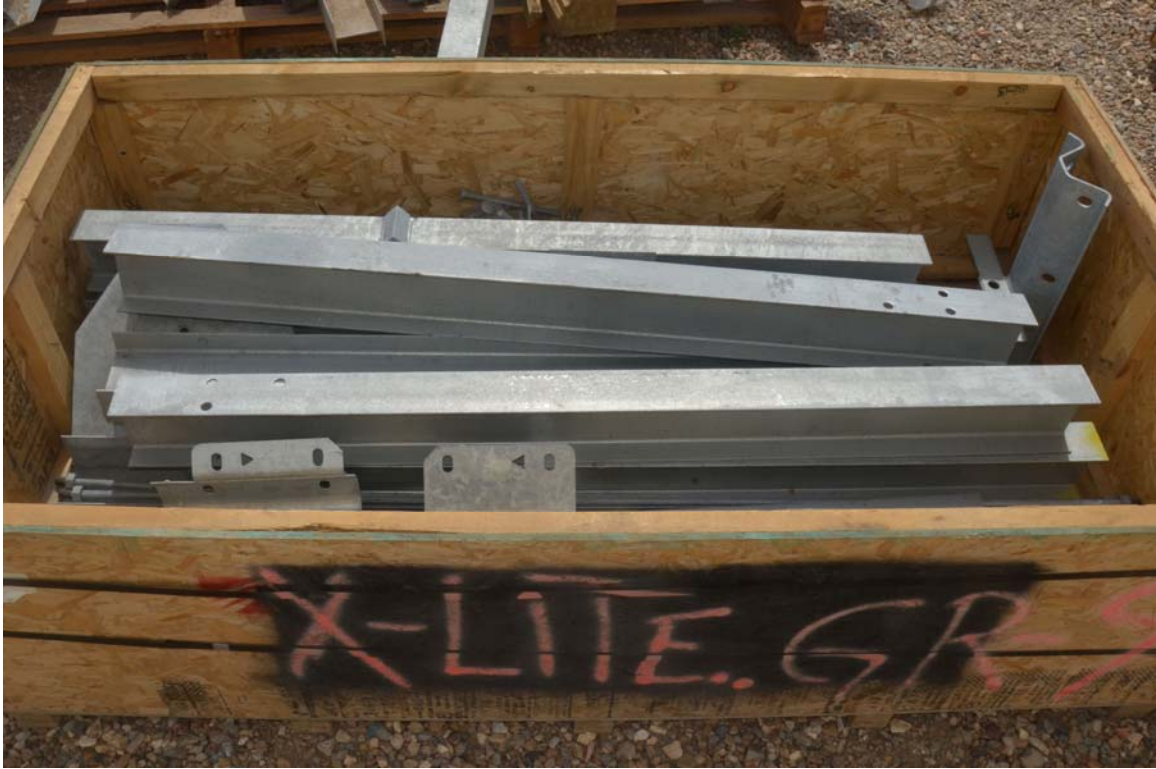
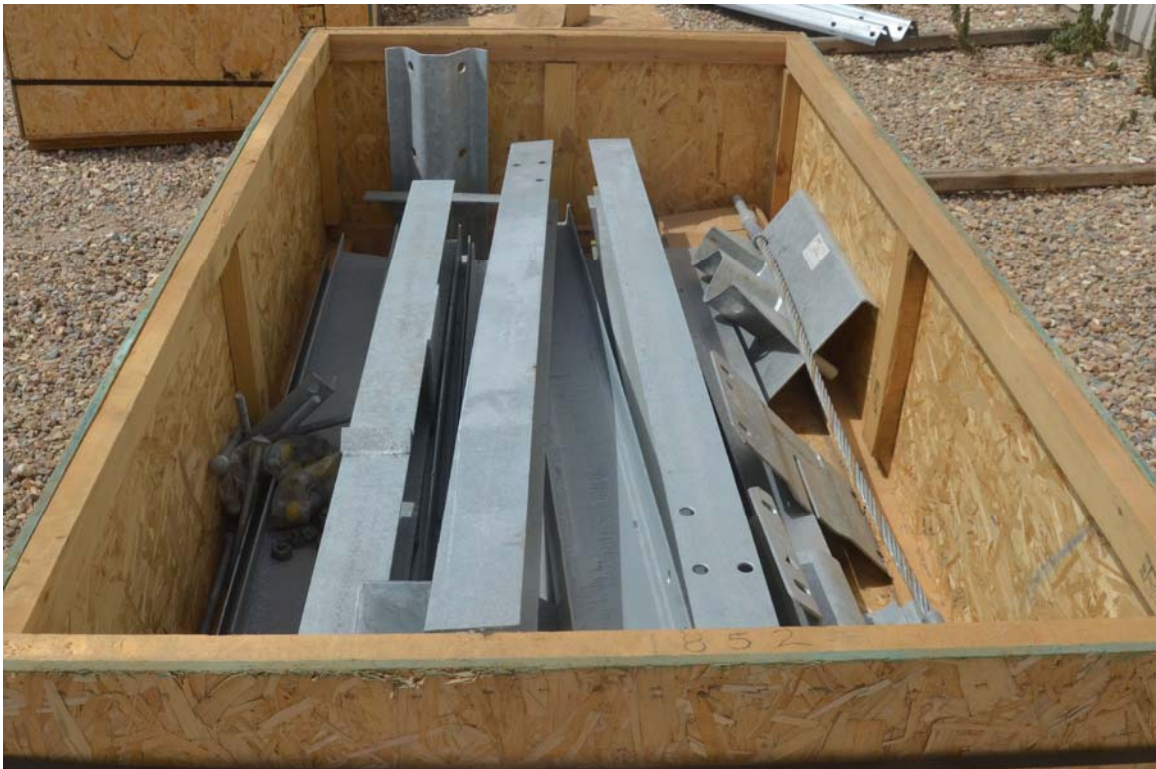
FIGURE 1. Test Article, As Received

FIGURE 2. Test Article, As Received

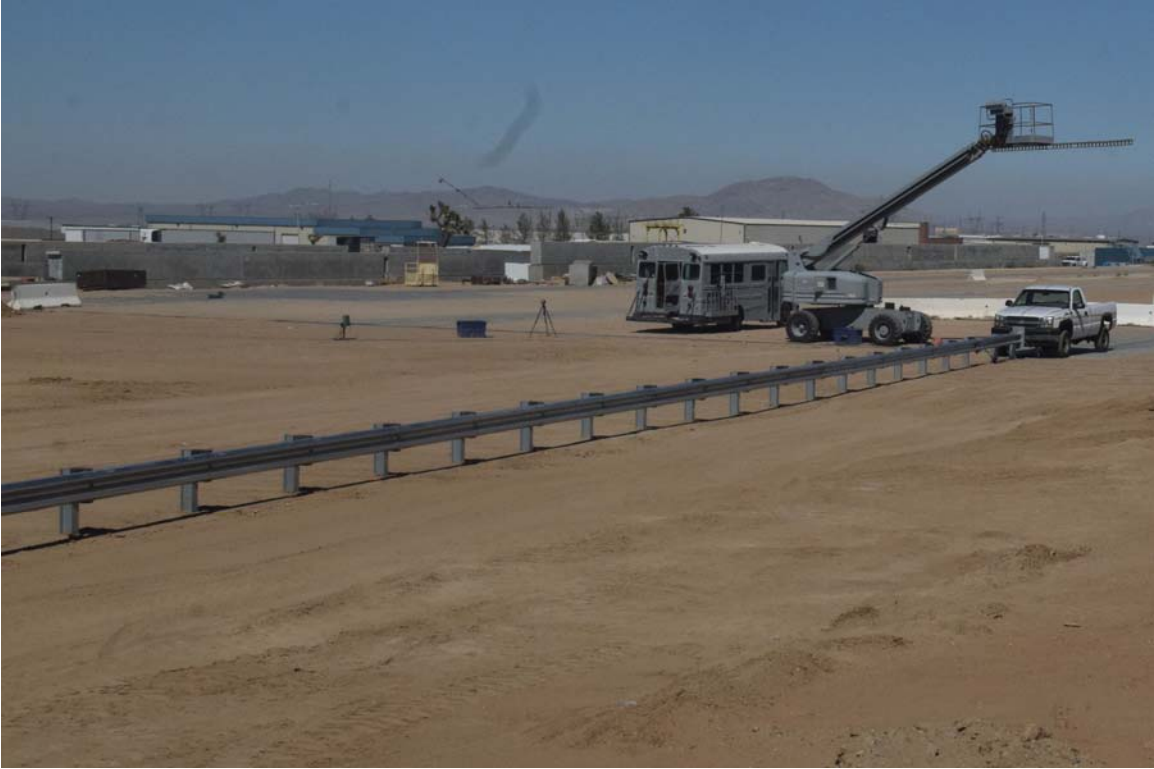
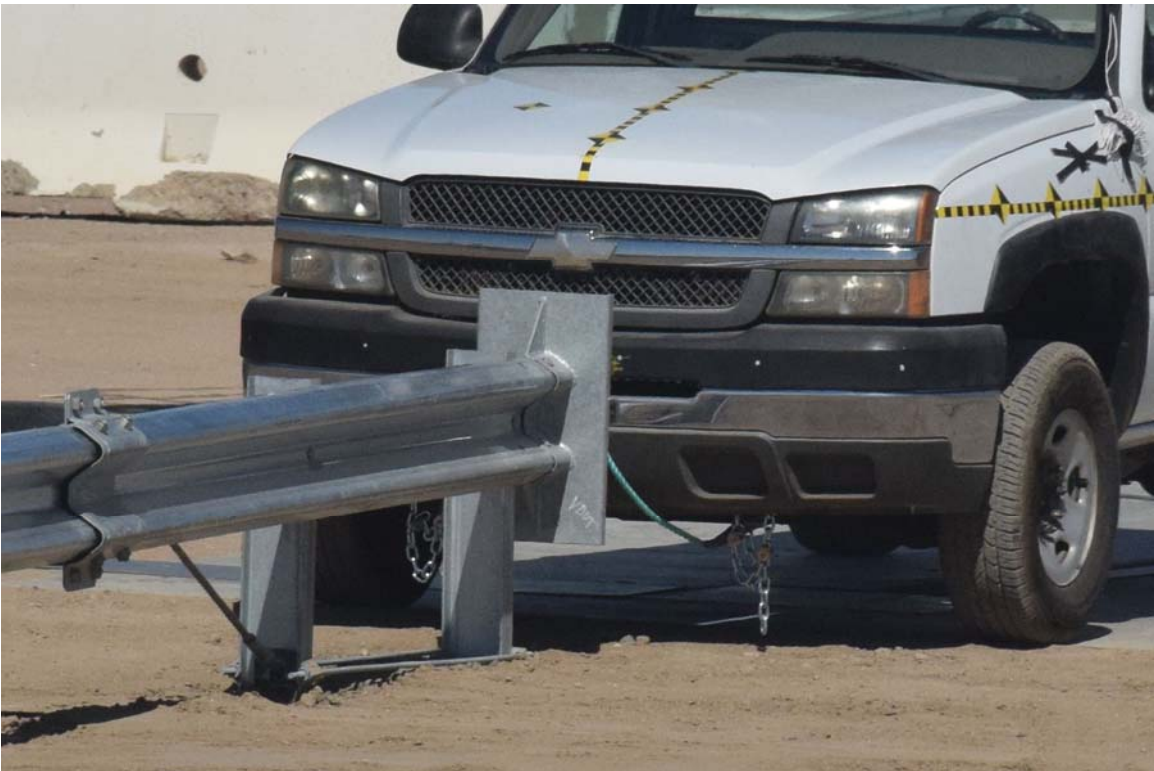
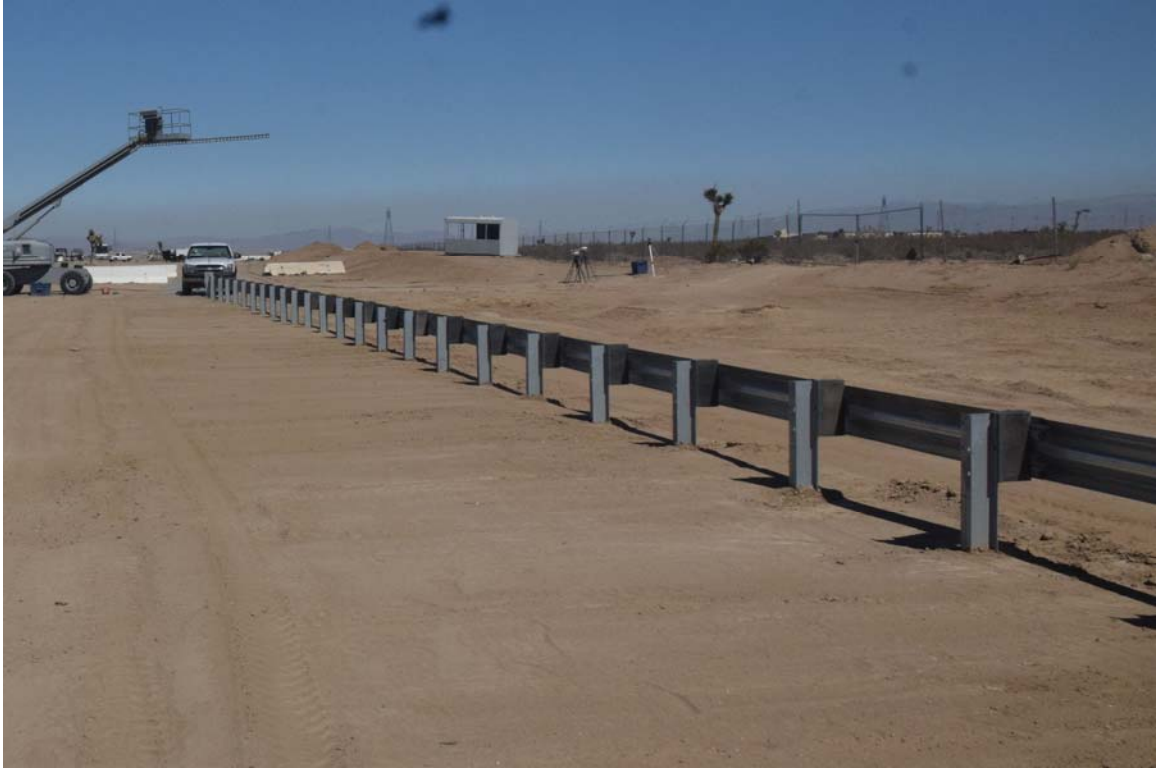
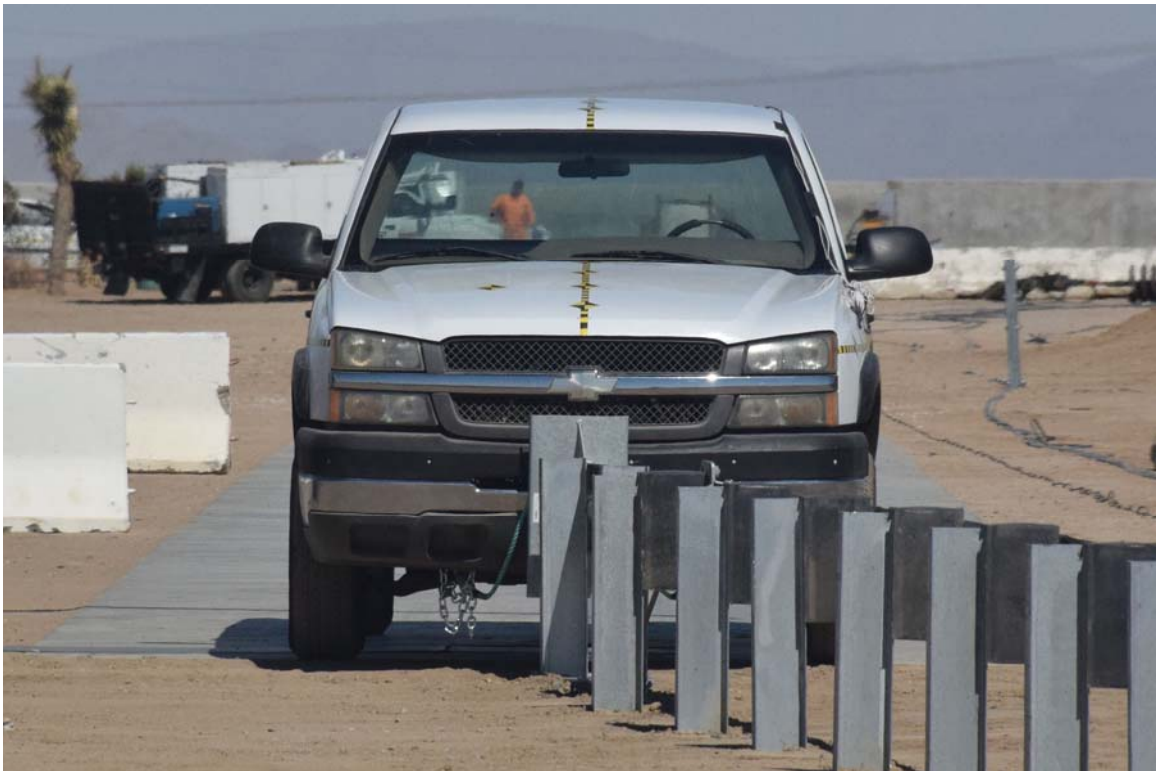
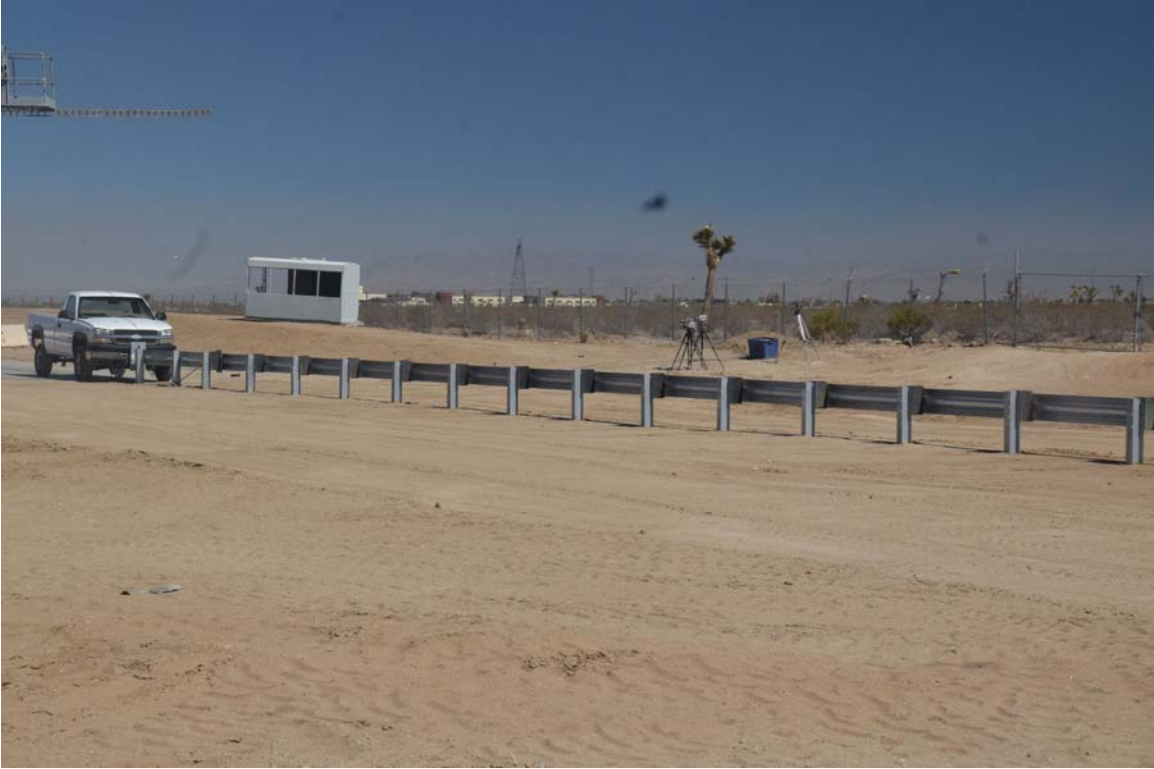
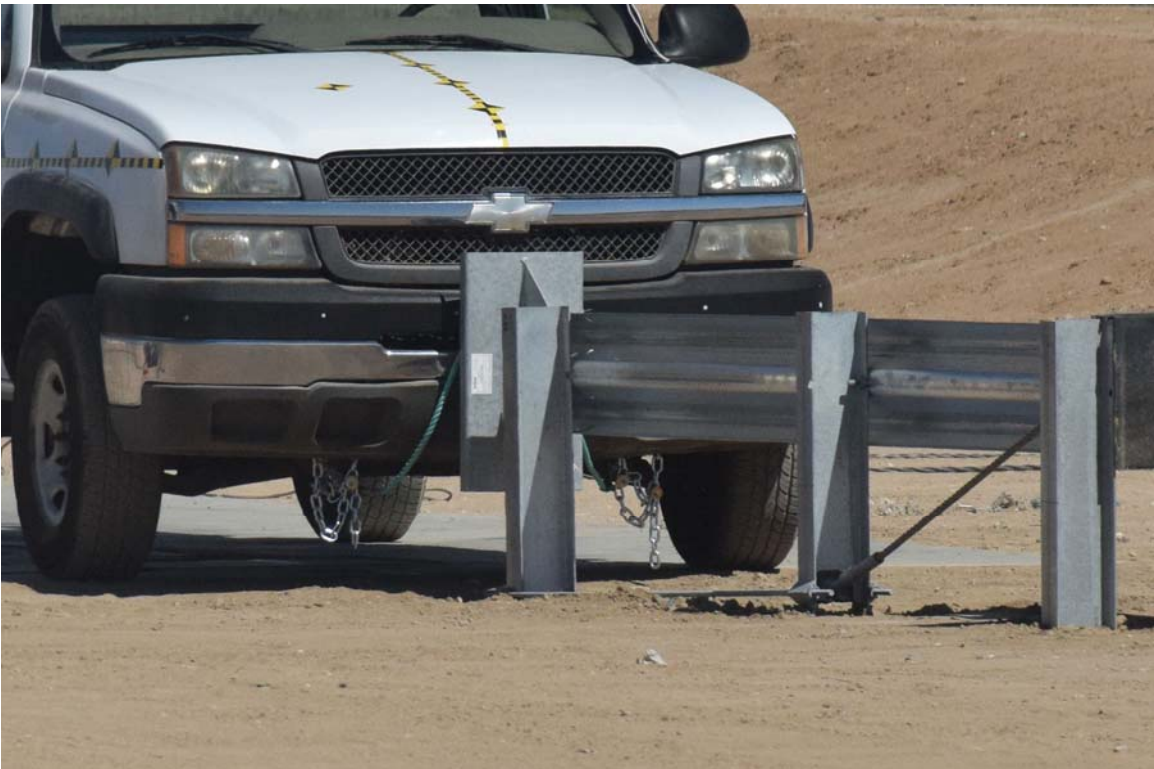
FIGURE 5. Test Setup

FIGURE 6. Test Setup Close-Up

A full-scale crash test was conducted to evaluate the impact performance of the X Lite Tangent 50' (15.24 m) System. The test conditions were as follows: A 2000 kg (4409 lb.) pickup truck approaching the test article at a nominal speed of 100 km/h (62 mph) with a critical impact angle of 5°. The test article was installed so that the vehicle centerline intersected the leading edge of the W-beam rail.

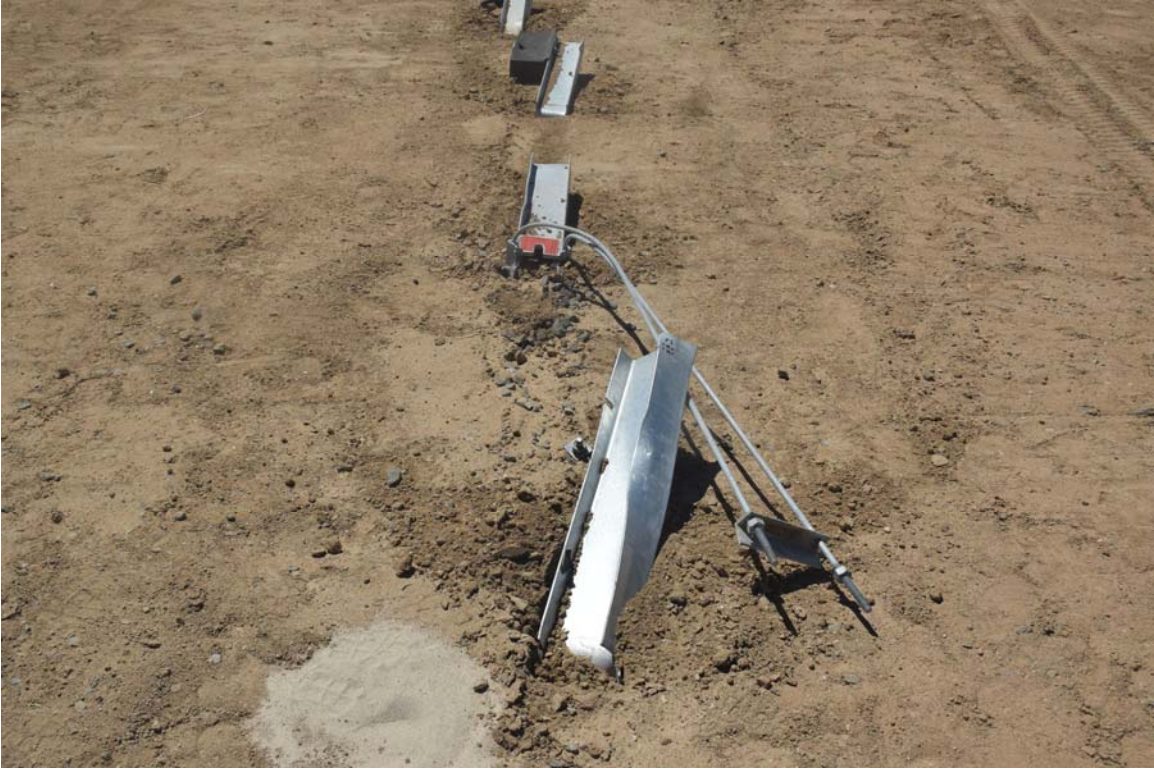
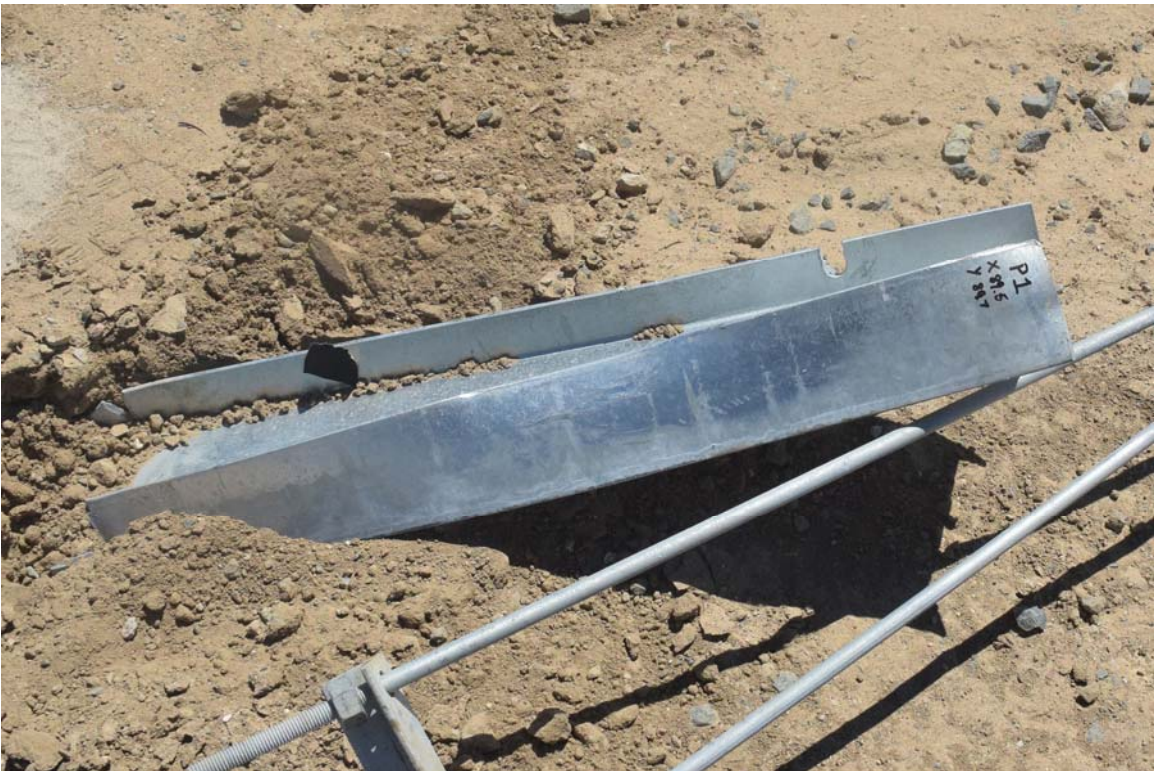
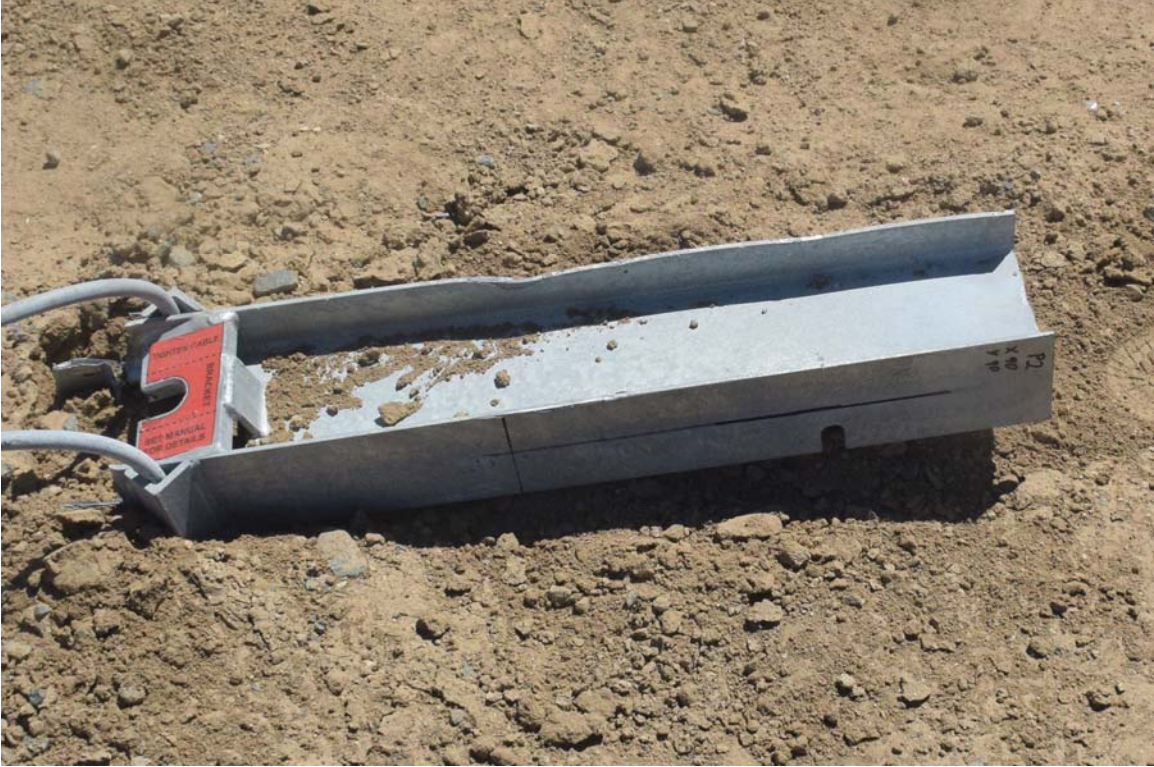
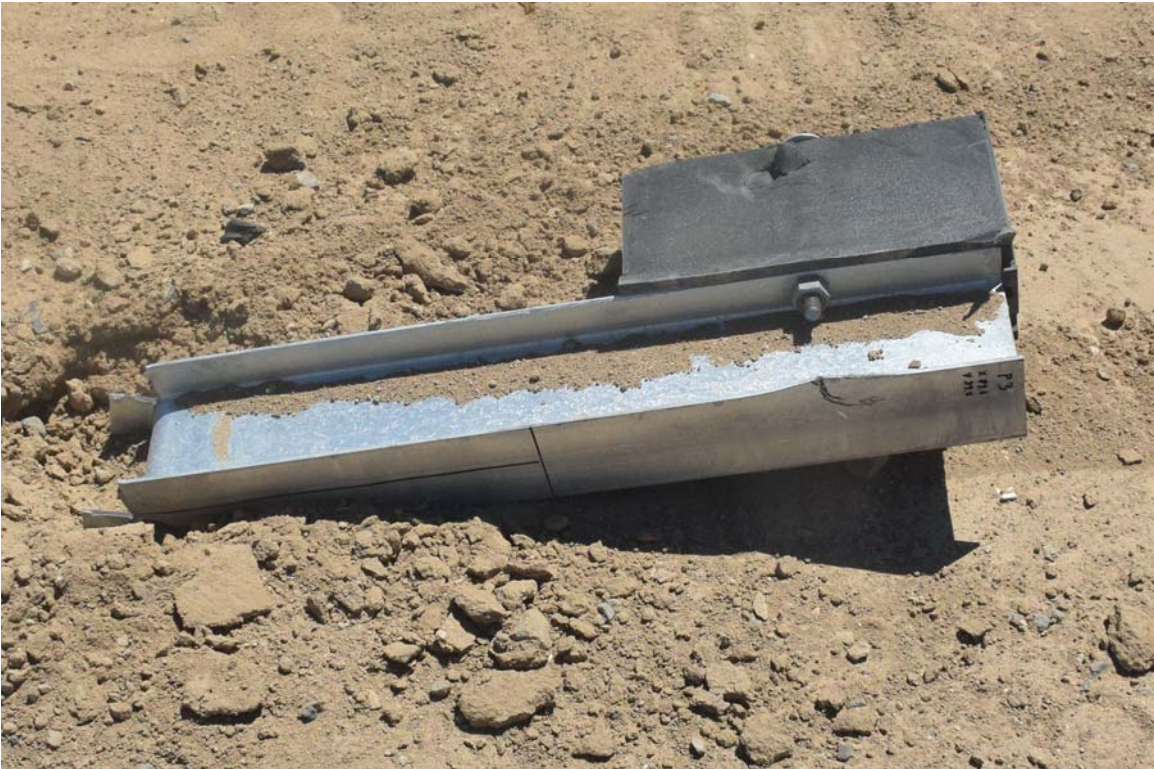
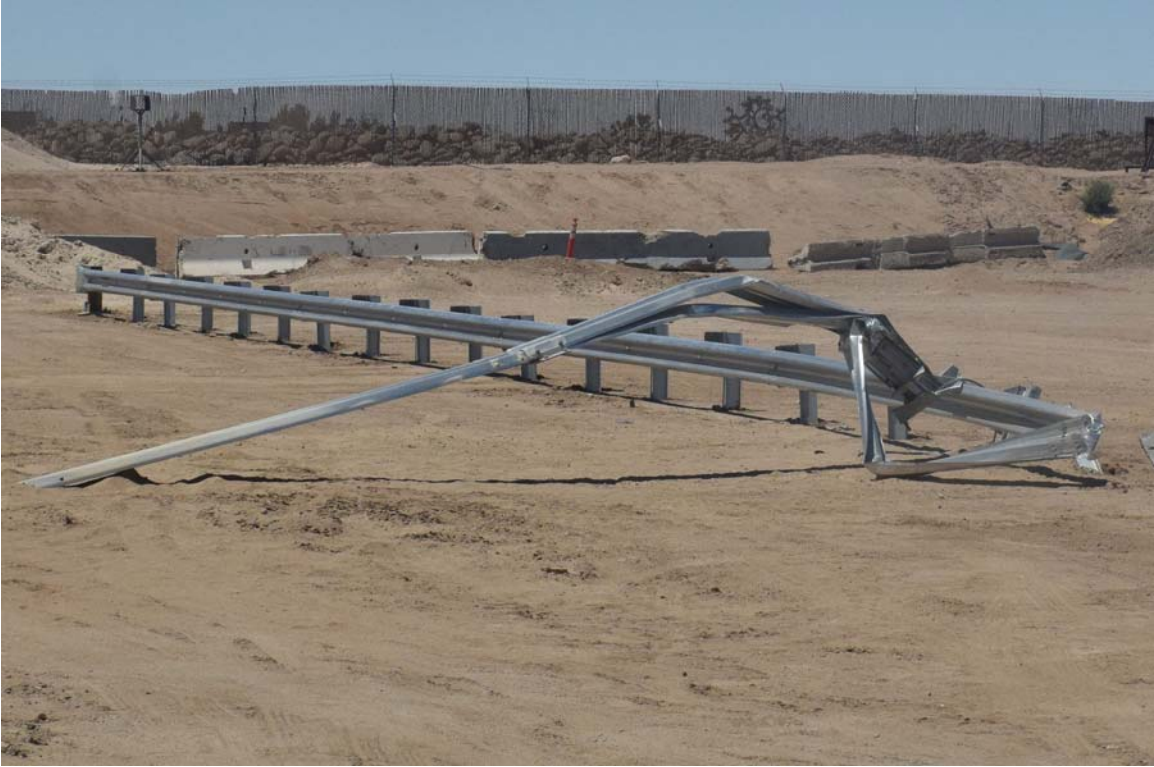
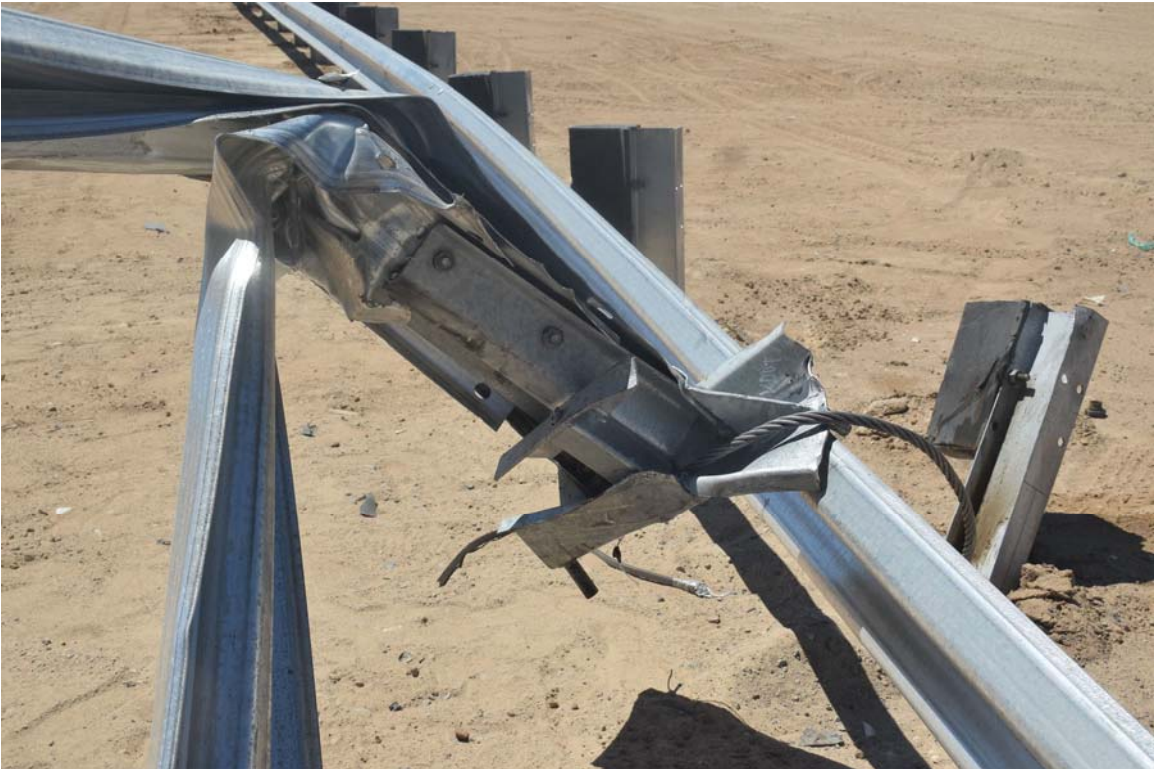
FIGURE 33. Test Article Damage

FIGURE 34. Test Article Damage

FIGURE 35. Test Article Damage

FIGURE 36. Test Article Damage

FIGURE 37. Test Article Damage

FIGURE 38. Test Article Damage

The test vehicle impacted the X Lite Tangent 50' (15.24 m) System at a velocity of 97.28 km/h (60.45 mph). The test vehicle impacted the X Lite impact head and pushed rail 1 down rail 2. As the vehicle moved forward the shear bolts on the downstream end of rail 3 sheared. Rails 1 and 2 deformed and rail 3 detached from the system. The vehicle began to rotate counter clockwise about its yaw axis and subsequently rolled onto its passenger side. The vehicle came to rest 23.8 m (78.1 ft.) from the initial impact point. The test vehicle directly impacted post 1 through 11 bending them towards the ground. The remaining downstream posts shifted in the soil causing the rail to tear from all post that did not have a rail splice. The impact head and slider bracket were subject to deformation. An overhead illustration of the test vehicle and test article in their pre-test and post-test condition is shown in figure 2 in Appendix D. Sequential photographs of the test sequence are shown on Data Sheet 4.

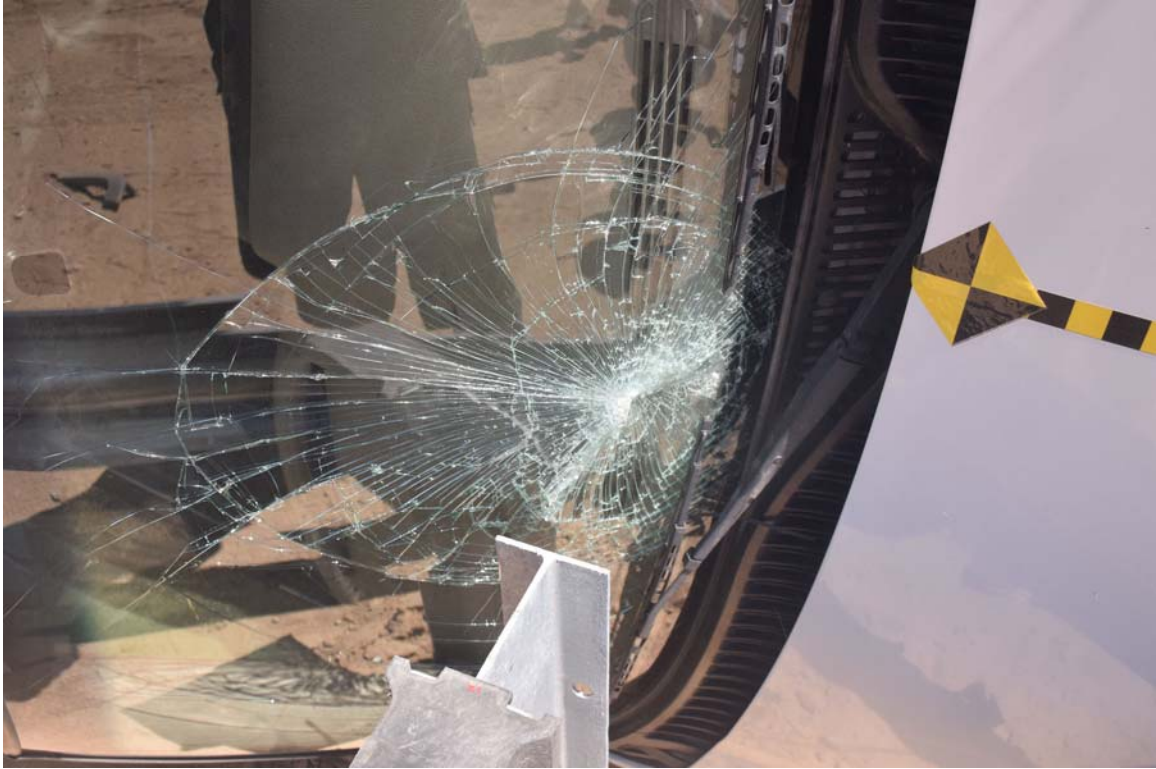
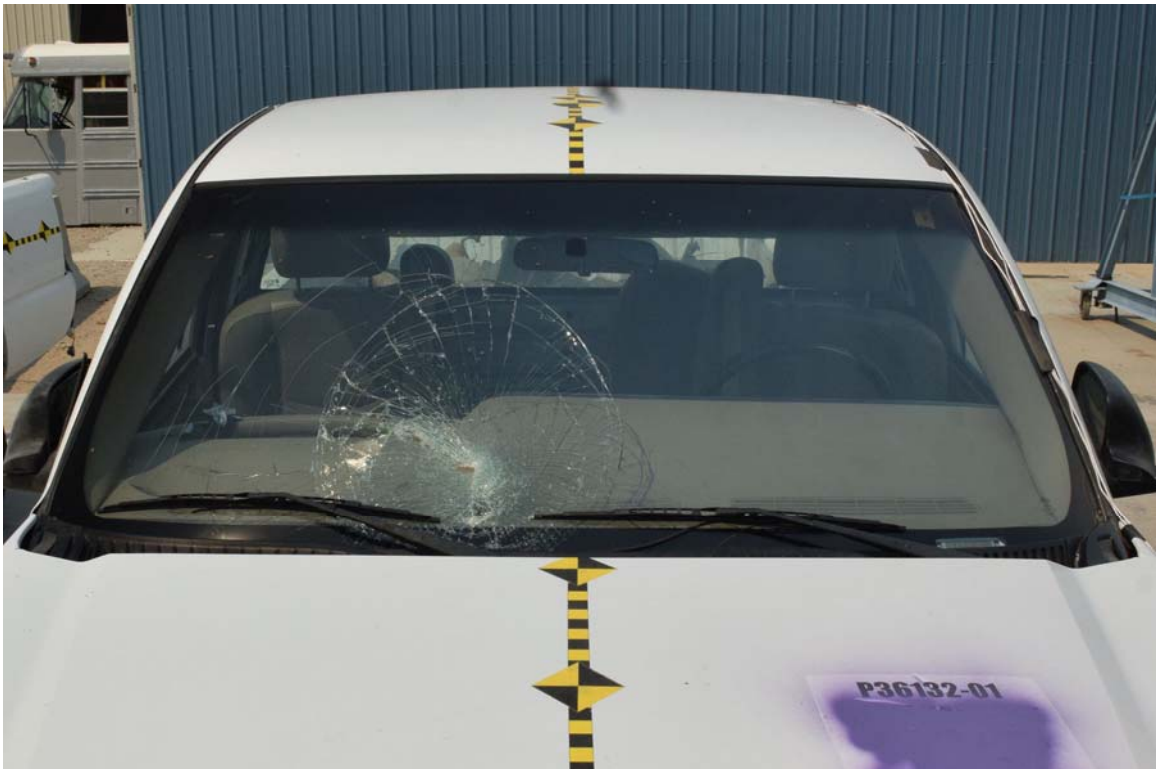
FIGURE 49. Post-Test Windshield

FIGURE 50. Post-Test Windshield

The vehicle sustained damage to the front end including the front bumper, grill and radiator. The right side of the vehicle was damaged including damage to the right front quarter panel, bed side and door. The windshield of the vehicle was penetrated by a line post during roll over.

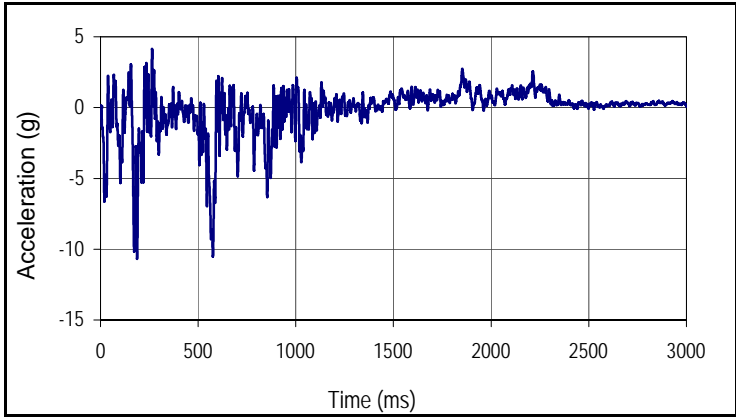
Curve Description			
Test Vehicle CG X			
Plot No.	Type	SAE Class	Units
001	FIL	60	g
Max	Time	Min	Time
4.1	264.3	-10.7	187.2

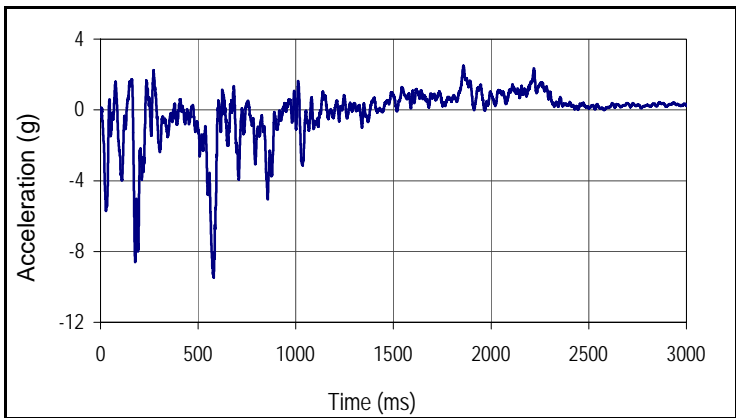
Curve Description			
Test Vehicle CG X Moving Average			
Plot No.	Type	SAE Class	Units
002	AVG	180	g
Max	Time	Min	Time
2.5	1858.0	-9.5	579.6

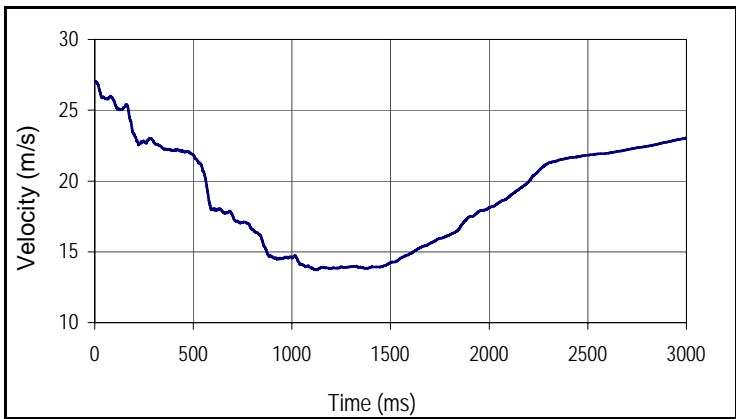
Curve Description			
Test Vehicle CG X Velocity			
Plot No.	Type	SAE Class	Units
003	IN1	180	m/s
Max	Time	Min	Time
27.0	3.8	13.7	1126.8

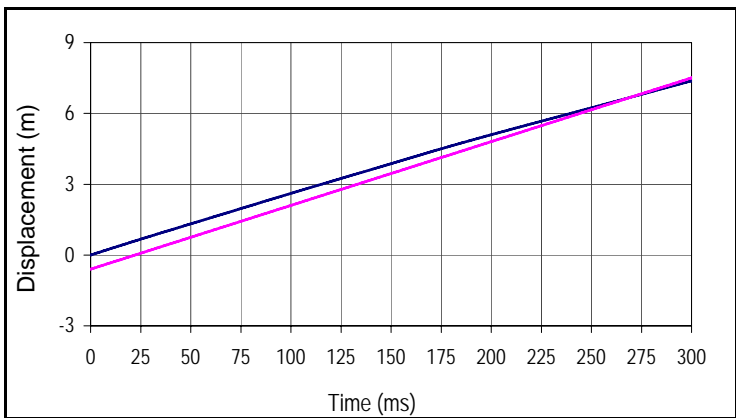
Curve Description			
Test Vehicle CG X Displacement			
Plot No.	Type	SAE Class	Units
004	IN2	180	m
Max	Time	Min	Time
56.7	2999.9	0.0	0.0

— Vehicle CG X Displacement  
 — Occupant X Displacement

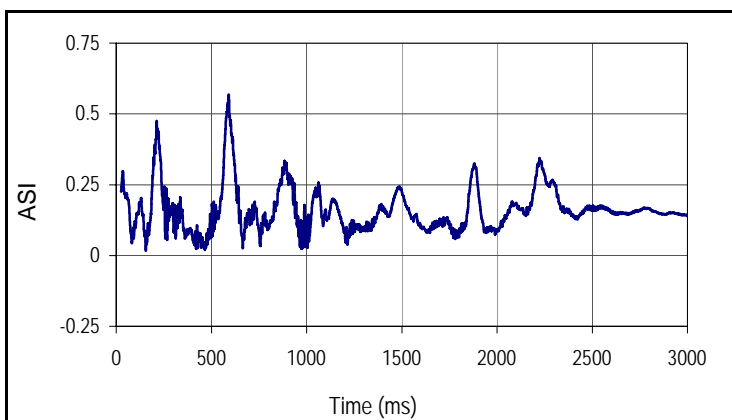
Curve Description			
Test Vehicle Accident Severity Index			
Plot No.	Type	SAE Class	Units
010	ASI	180	ASI
Max	Time	Min	Time
0.6	590.8	0.0	155.2

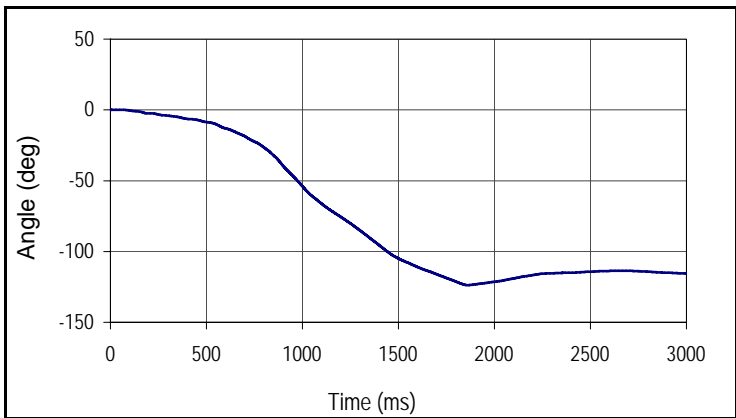
Curve Description			
Test Vehicle Yaw Angle			
Plot No.	Type	SAE Class	Units
012	IN1	180	deg
Max	Time	Min	Time
0.1	63.9	-123.7	1859.7

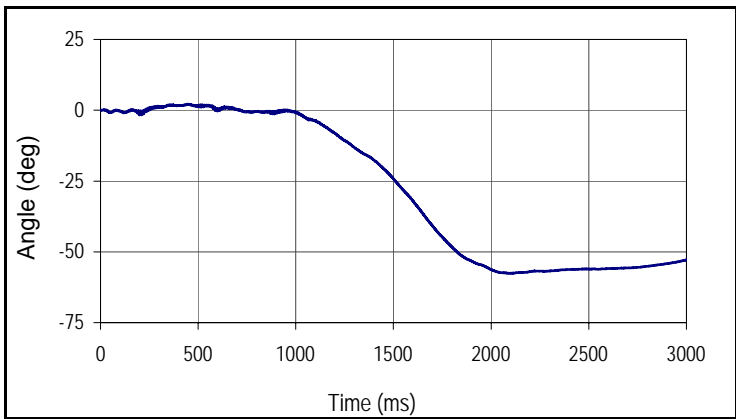
Curve Description			
Test Vehicle Pitch Angle			
Plot No.	Type	SAE Class	Units
013	IN1	180	deg
Max	Time	Min	Time
2.2	445.9	-57.6	2102.8

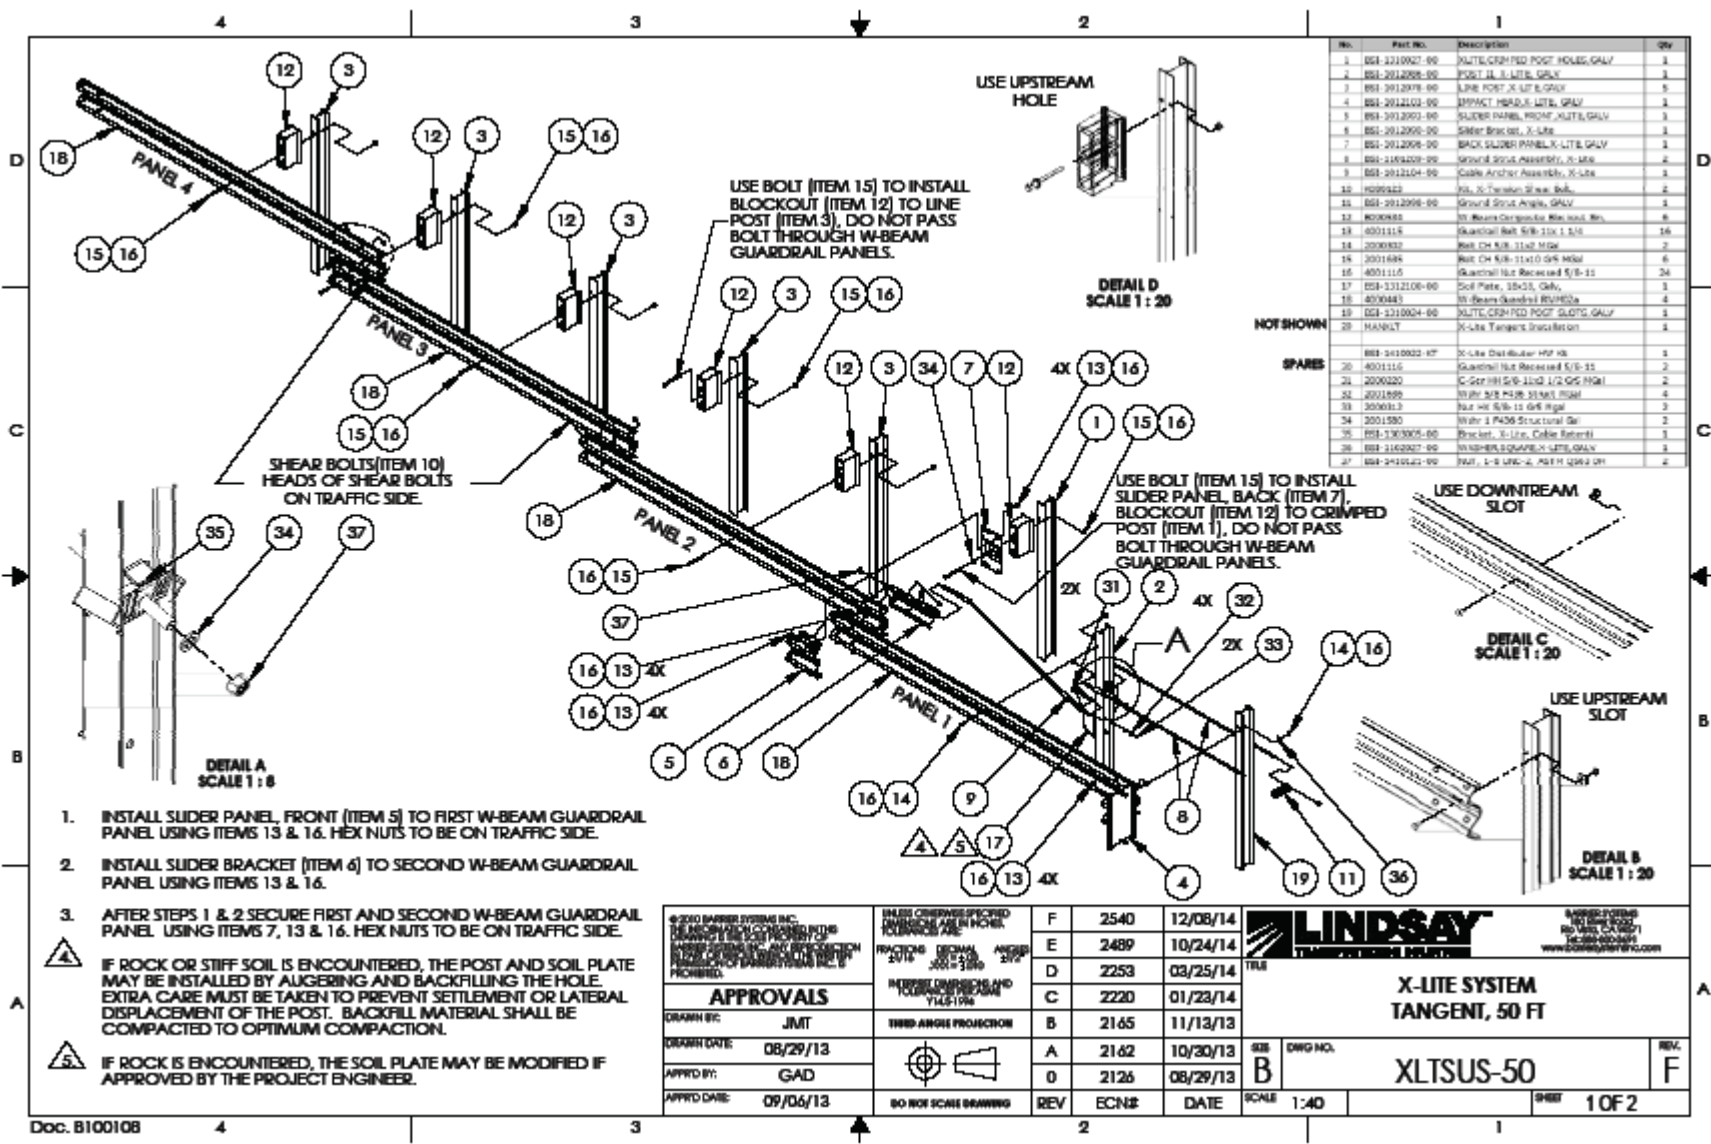
FIGURE 1. Manufacturer's Drawing

The Lindsay Corporation X Lite Tangent 50' (15.24 m) System is a standard post guardrail terminal/end treatment. The as-tested X Lite Tangent 50' (15.24 m) System consisted of two (2) crimp posts, one (1) post 2 assembly, ground strut, slider assembly, four (4) W-beam guardrail panels, five (5) standard line posts, six (6) composite blocks, and an impact head. The terminal was installed with a 50:1 flare and a rail height ranging from 705 mm (27.75 in.) to 730 mm (28.75 in.) per Virginia Department of Transportation (VDOT) Road and Bridge Standards.

Post 1 and 3 each consisted of one (1) 1.8 m (6.0 ft) long post constructed of W6 X 8.5 I-beam with crimps located 820 mm (32.3 in.) down from the top on both of their flanges. Post 2 consisted of one (1) 1.8 m (6.0 ft) long post constructed of W6 X 8.5 I-beam and had one (1) 38 mm (1.5 in.) square angle welded on each flange 660 mm (26.0 in.) from the top. A 457 mm (18.0 in.) tall by 457 mm (18.0 in.) wide by 8 mm (0.3 in.) thick soil plate was bolted to the downstream end of post 2 with two (2) 0.625 in. x 3.5 in. bolts, nuts, and washers. The remaining five posts were 1.8 m (6.0 ft.) long standard line posts composed of W6 x 8.5 I-beam.

A front slider panel 371 mm (14.625 in.) long by 3 mm (0.125 in.) thick was mounted at post 3 on the traffic side of the W-beam guardrail with four (4) 0.625 in. x 2.0 in. guardrail bolts and nuts. The slider bracket and slider panel were also mounted at post 3 between the W-beam guardrail and composite block. The slider bracket was 549 mm (21.625 in.) long by 6 mm (0.25 in.) thick and had a 64 mm (2.5 in.) square tube welded on the backside through which the cable anchor was routed. The slider panel was 445 mm (17.5 in.) long by 270 mm (10.625 in.) tall by 5 mm (0.19 in.) thick. The slider panel and composite block were mounted to post 3 with a 0.625 in. x 10 in. long bolt and a 25 mm (1.0 in.) washer.

Four (4) 3.8 m (12.5 ft.) long 12 Ga W-beam guardrail panels are mounted to the posts of the terminal section with the splice located at every other post. The first rail panel was mounted to post 1 via a 0.625 in x 2.0 in. hex bolt, 50 mm (2 in.) square washer, and nut. Post 2 is also mounted to the rail with a 0.625 in. x 2.0 in. The 191 mm (7.5 in.) offset blocks are placed between the remainder of the terminal's line posts and the rail panels. One (1) 0.625 in. x 10.0 in. long bolt, washer, and nut was used to mount the rail to each of the line posts with offset blocks. The rail was not bolted to post 3 and post 5. Yellow 16 mm (0.625 in.) shear bolts were used to splice rail 3 at both the upstream and downstream ends. All posts were spaced at a nominal distance of 1.9 m (6.25 ft.).

The face of the impact head measured 610 mm (24.0 in.) tall by 330 mm (13.0 in.) wide by 5 mm (0.19 in.) thick. A 165 mm (6.5 in.) long by 5 mm (0.19 in.) thick W-beam section was welded to the back of the impact face and was used to mount the impact head to the terminal's first W-beam rail. The W-beam section was reinforced to the impact face with two (2) 165 mm x 127 mm x 6 mm (6.5 in. x 5.0 in. x 0.25 in.) triangular gussets. The impact head was mounted to the rail with four (4) 0.625 in. x 1.25 in. bolts.

Photographs of the as-tested unit and installation are available in Appendix A of this report. Manufacturer's drawings are available in Appendix D. The installation instructions are included on KARCO CD-R 2016-4063.
