**Virginia Department of Transportation**  
**X Lite Tangent 50' (15.24 m) System**

**TR-P36132-01-NC**

Test Article:     X Lite Tangent 50' (15.24 m) System          Project No.     P36132-01      
 Test Program:     100 km/h 5° Guardrail Terminal Impact Test          Test Date:     08/11/16

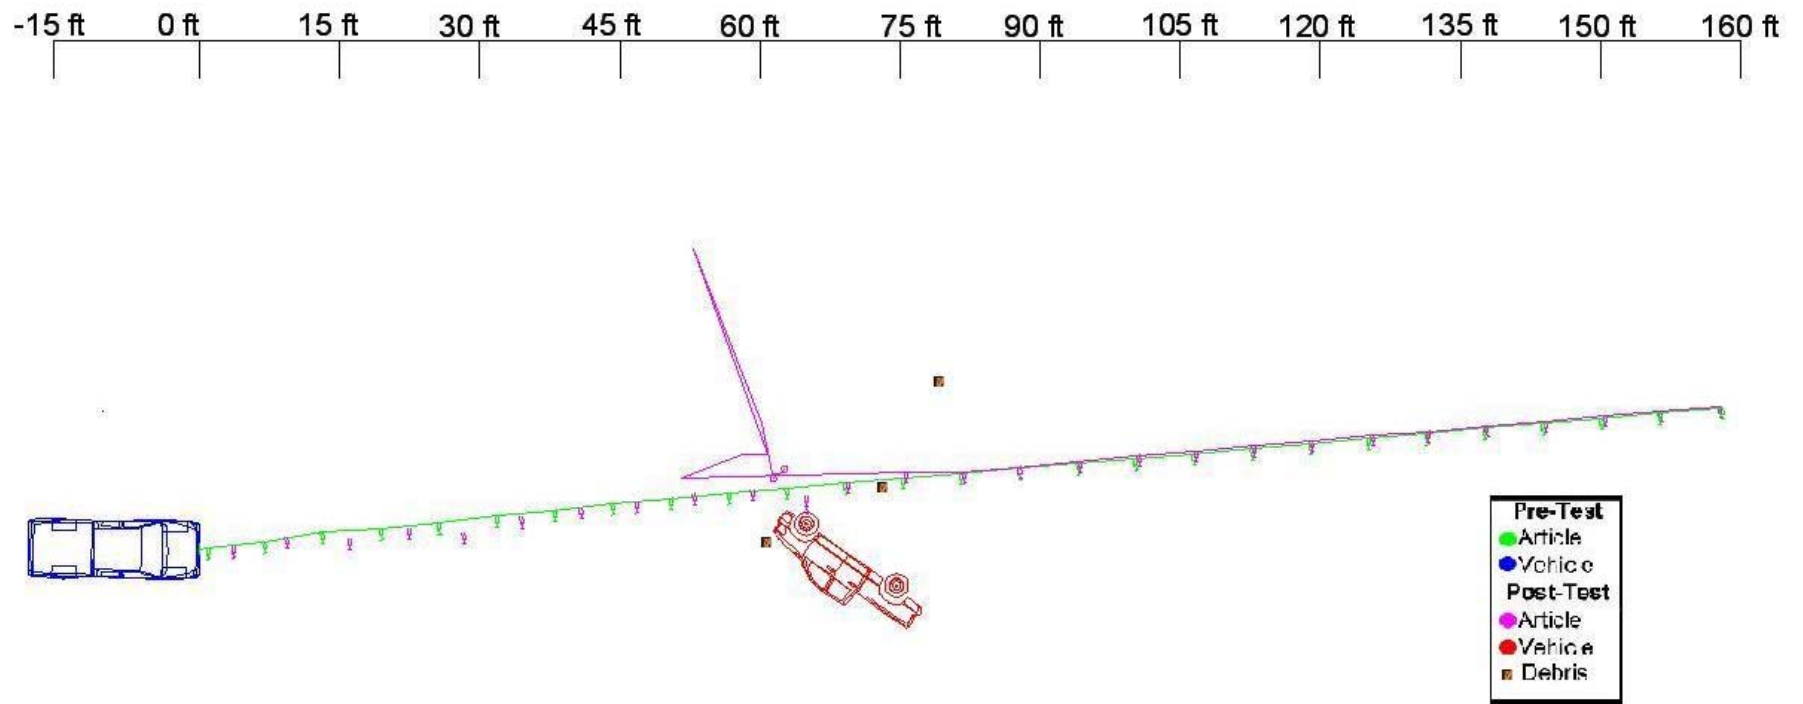
FIGURE 2. Overhead Illustration  
 FINAL PAGE OF REPORT

For this test, the X Lite Tangent 50' (15.24 m) System was adjoined to the end of a 34.3 m (112.5 ft.) length of guardrail, measured from post 9 to post 27. The adjoining guardrail included a 3.8 m (12.5 ft.) long trailing end terminal treatment, measured from post 25 to post 27. The terminal's adjoining barrier consisted of seventeen (17) 1.8 m (6.0 ft.) long W6 x 8.5 standard I-beam line posts, one (1) 8" x 6" wood post with a soil plate and steel foundation tube, four (4) 7.6 m (25.0 ft.) long 12 Ga W-beam rail panels, one (1) 3.8 m (12.5 ft.) long 12 Ga W-beam rail panel, and one (1) cable anchor assembly. The 191 mm (7.5 in.) plastic offset blocks were on all posts except the last wooden post.
